WINDOWS FOR EXTERNAL OR INTERNAL HYDROSTATIC PRESSURE VESSELS

PART II. Flat Acrylic Windows Under Short-Term Pressure Application

NAVAL FACILITIES ENGINEERING COMMAND

Technical Report R-527

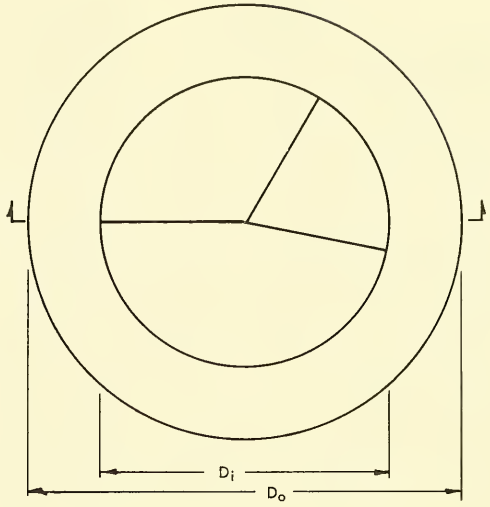
In nearly all cases for all sizes of windows tested, failure began with radial cracking on the window's low-pressure face. Radiating outward from near the center, the cracks commonly formed a nonsymmetrical, three- or four-pointed figure. This form of cracking preceded failure in nearly all cases and is assumed to be the beginning of failure (Figures B-1 and B-2). Depth of cracking was found to be a function of the thickness, t/D_i ratio of the window, and the pressure of the fluid. Since audible cracking was noted during testing, it is postulated that these radial cracks were rapidly formed, terminating at the window's D_i. Depth of cracking in the low-pressure face in most cases was found to be a small fraction of the window's thickness.

Figure B-1. Initial radial crack pattern in low-pressure face of windows.

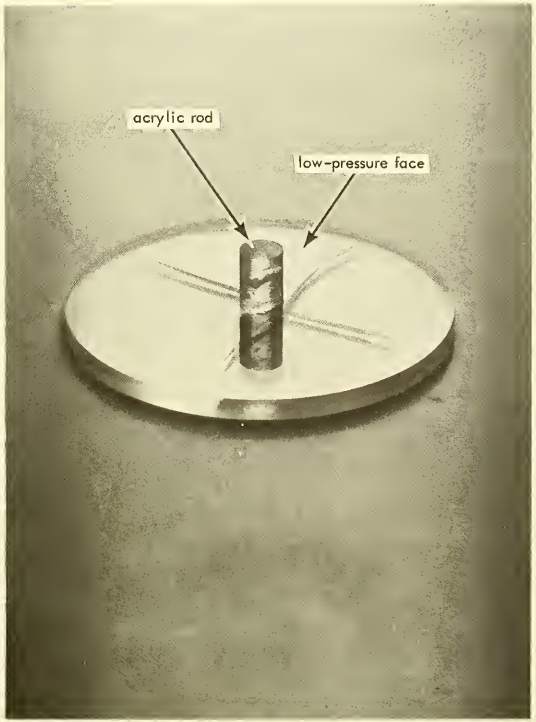
Figure B-2. Crack pattern in failed 0.122-inch-thick window with a t/D_i ratio of 0.081. Maximum pressurization 62 psi.

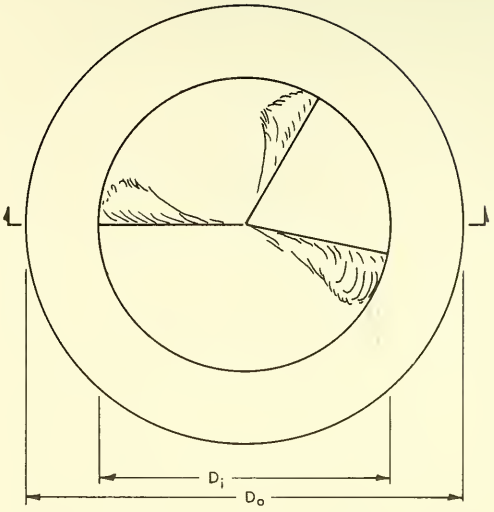
With additional pressurization, a second stage of failure began to develop. A conchoidal or "cupped cone" fracture was established, emanating from the base of the radial cracks and proceeding radially inward and circumferentially (Figures B-3 and B-4). The formation of a conchoidal fracture surface preceded failure in all cases observed.

Figure B-3. Second stage conchoidal fracture pattern, early development.

Figure B-4. Conchoidal fracture pattern in partially failed 0.355-inch-thick window with a t/D_i ratio of 0.237. Maximum pressurization 2,990 psi.

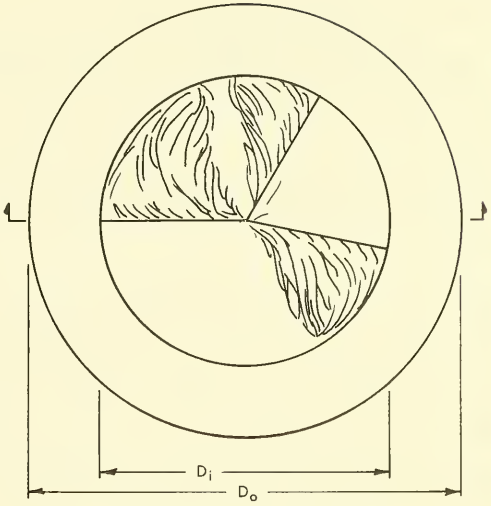
Simultaneously, as the conchoidal fracture surface was formed, the radial cracks increased slightly in depth (Figures B-5 and B-6). Cracks did not deepen uniformly and new cracks developed with further pressurization. The additional cracking gave rise to formation of new and deeper conchoidal fracture surfaces. Additional pressurization caused the circumferential expansion and coalescence of the conchoidal fracture surfaces into one conical fracture surface as well as an increase in fracture depth (Figures B-7 and B-8). Cracking and formation of conchoidal fracture surfaces continued (Figures B-9 and B-10) deeper into the window's thickness until the critical pressure was finally reached resulting in the fragmentation and expulsion of the window's low-pressure face (Figures B-11 and B-12). The size of the central hole was a function of t/D_i ratio and D_i. The conical cavity resulting from the expulsion of the center portion of the window consistently assumed an approximate angle of 30 degrees with the high-pressure face.

Figure B-5. Conchoidal fracture pattern, advanced stage of development.

Figure B-6. Advanced stage of conchoidal fracture pattern in 0.857-inch-thick window with a t/D_i ratio of 0.572. Maximum pressurization 20,100 psi.

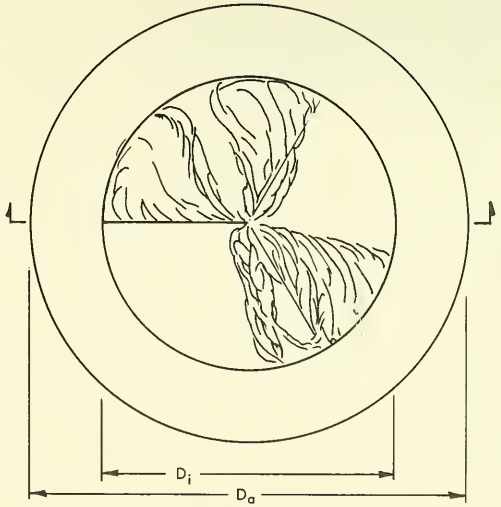
Figure B-7. Imminent coalescence of conchoidal fractures as critical pressure is approached.

Figure B-8. Coalescing conchoidal fractures just prior to failure in a 0.735-inch-thick window with a t/D_i ratio of 0.490; maximum pressurization 18,600 psi.

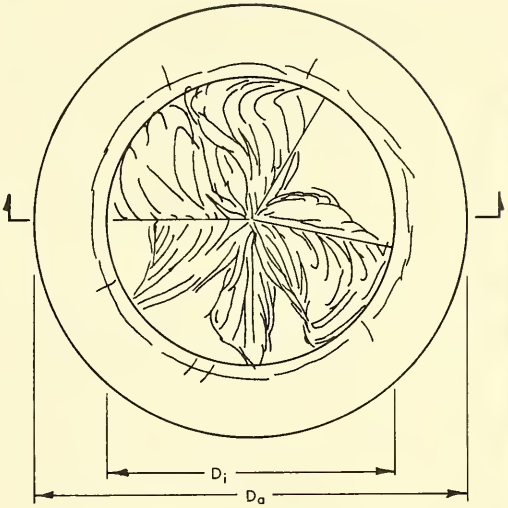
Figure B-9. An advanced stage of coalescence of conchoidal fractures as critical pressure is approached.

Figure B-10. A 0.735-inch-thick window with t/D_i ratio of 0.490 pressurized to 19,000 psi. Note extrusion at the window's D_i and penetration depth of the conchoidal fracture into the window.

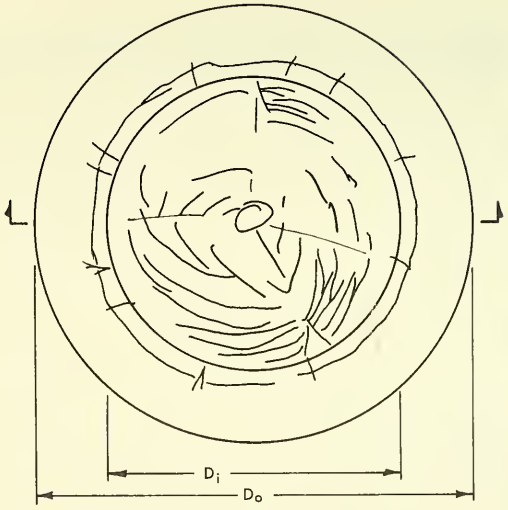
Figure B-11. The type of failure which follows complete coalescence of conical fracture surfaces.

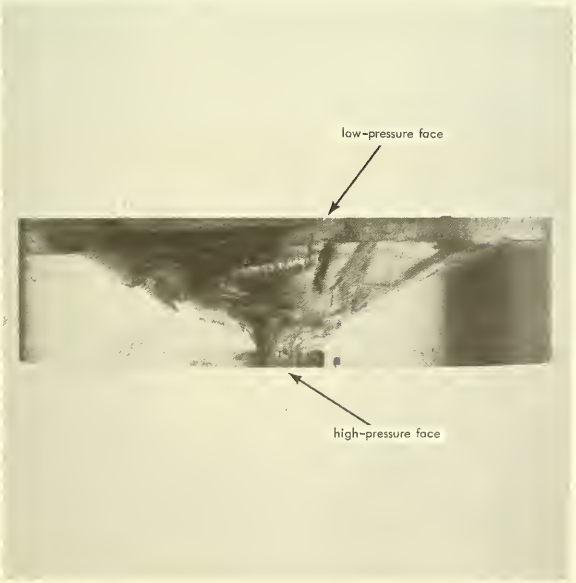
Figure B-12. A 0.600-inch-thick window with a t/D_i ratio of 0.400 which failed at 13,000 psi.

For a t/D_i ratio between 0.2 and 0.4 the principal failure was conical, the cone's apex reaching the high-pressure face toward the upper limit of critical pressure (Figure B-12). Audible cracking during pressurization occurred mostly at levels above 75% of critical pressure and occurred fairly consistently between 90% of critical pressure and failure.

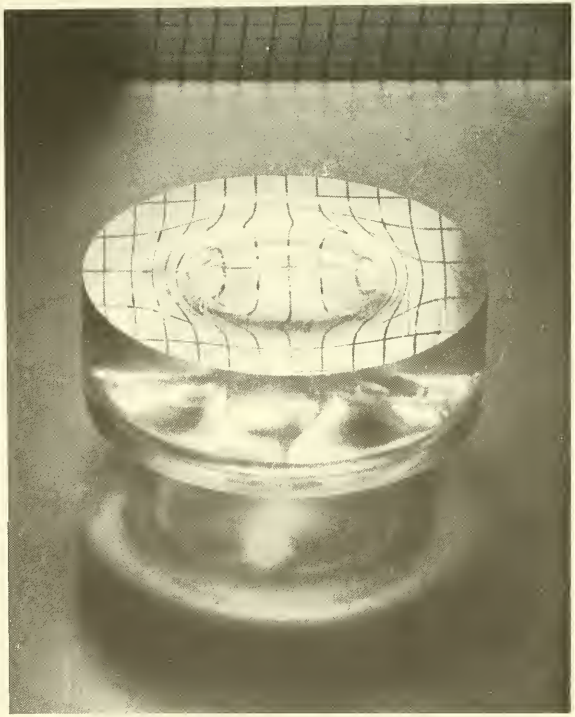
Considerable cold-flow cratering occurred on the high-pressure face before the critical pressure was reached (Figure B-13). Both elastic and plastic extrusion on the low-pressure face were also experienced by the window at this time (Figure B-14).

Figure B-13. Plastic flow cratering on the high-pressure side of a 0.735-inch-thick, 0.490 t/D_i ratio window subjected to 18,600 psi pressure.

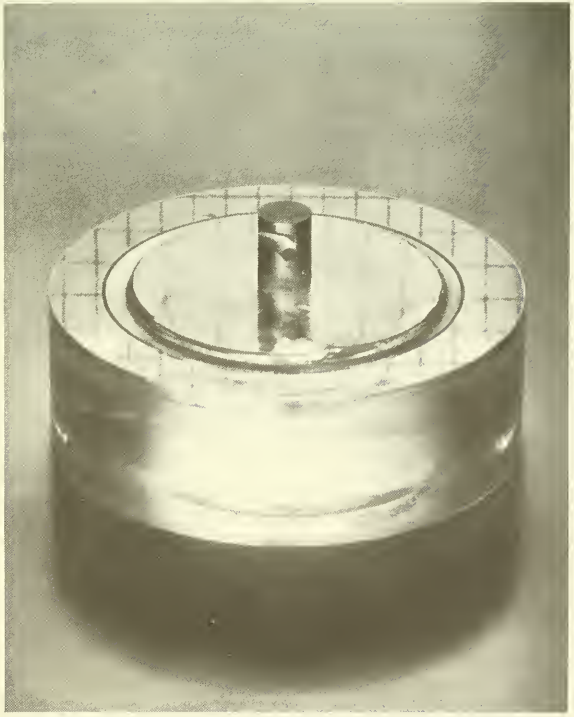
Figure B-14. Extrusion of the unsupported low-pressure face of a 0.735-inch-thick, 0.490 t/D_i ratio window subjected to 18,600 psi pressure.

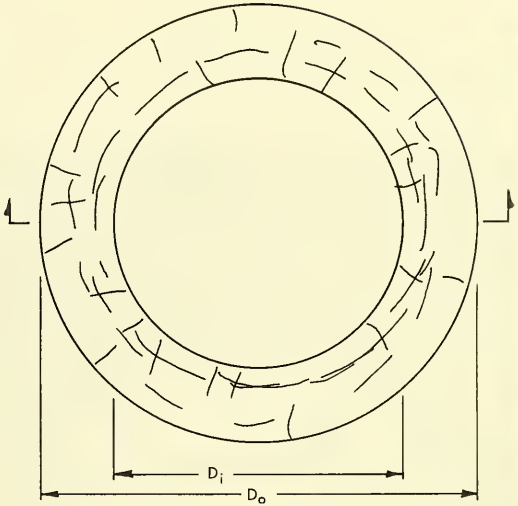
Windows whose t/D_i ratios exceeded about 0.50 failed predominately by shear; the conical fracture surface was unable to penetrate the thickness of the material (Figures B-15 and B-16). At the critical pressure, the entire window was penetrated by discontinuous cracks and the central portion (bounded by D_i) was completely ejected.

Figure B-15. Shear-type failure common to windows with large t/D_i ratios.

Figure B-16. Shear-type failure in a 1.432-inch-thick, 0.500 t/D_i ratio window which failed at 15,300 psi.
